# Opportunities for Improved Cow Comfort through Freestall Barn Renovations

*Jeffrey Bewley, Animal and Food Sciences*

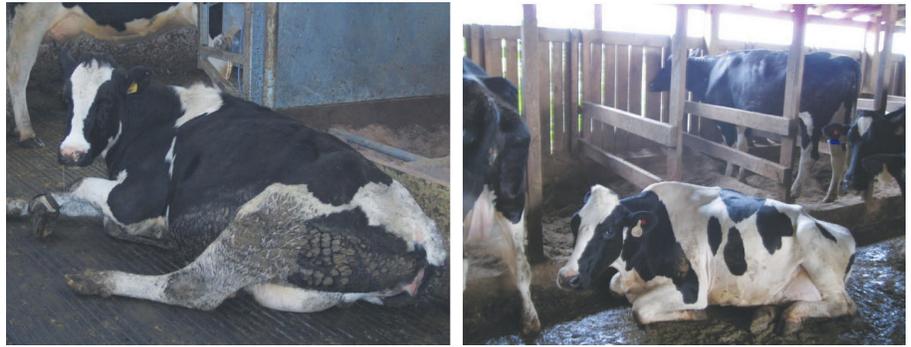
**Figure 1.** Cows choosing to lie in the freestall alleys rather than in the stalls may indicate that the freestalls do not provide a comfortable resting area.

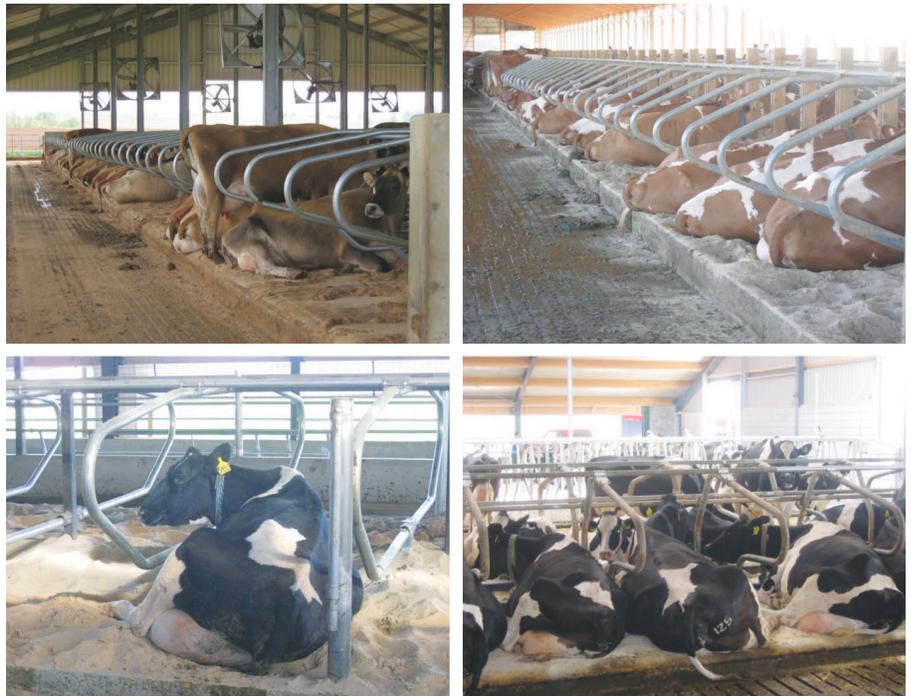
**Figure 2.** In well-designed and well-maintained freestalls, most cows will be observed resting comfortably or standing straight in the stall. In both positions, cows should be located parallel to the length of the stall.

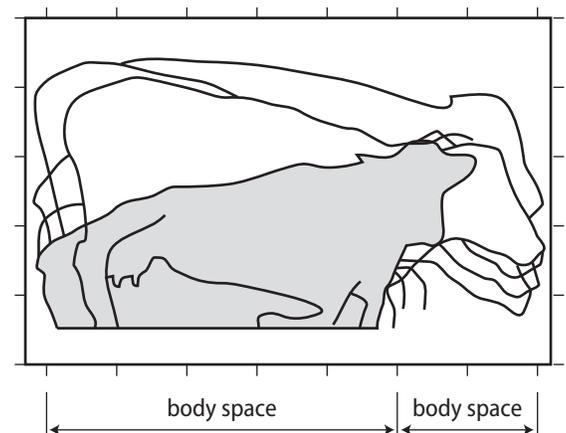
**Figure 3.** Space needed to accommodate the normal rising motion of a dairy cow.

Watch the cows as they lie in the stalls. Think about how a cow gets up when she is on pasture (**Figure 3**). Behavior in freestalls should be similar. McFarland describes how a cow typically rises: The cow will first shift to move her front knees beneath her body. Then, she lunges her head forward transferring weight to the front of her body, which also allows her rear end to be easily lifted. Next, she shifts weight to one knee and straightens the other front leg with the foot in front of the shoulder. Finally, she shifts her weight to the straightened leg, pushing up and straightening the other front leg to finalize her standing position.

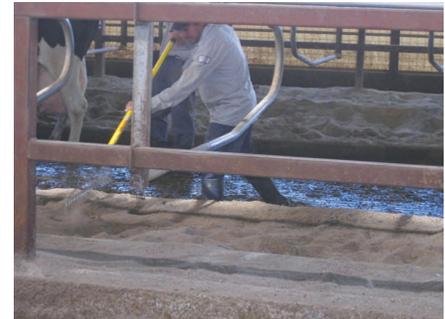
**Figure 4.** Frequent stall grooming can have a dramatic impact on stall usage and cow cleanliness.

Before renovating a freestall barn, determine whether cow comfort or cleanliness problems are the result of ineffective maintenance or actual design problems. Spending time grooming and cleaning freestalls can have a dramatic impact on cow cleanliness (Figures 4 and 5).

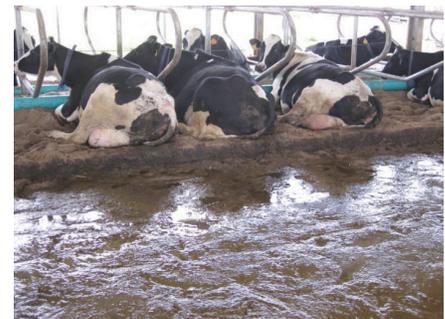
**Figure 5.** Cow cleanliness problems can often be attributed to infrequent or inadequate removal of manure and urine from freestall alleys.

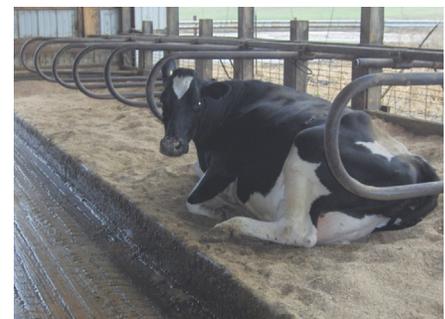
**Figure 6.** Detached or broken stall dividers or structures can lead to poor stall usage, dirty cows, or cow injury and entrapment.

Often, the first step to renovating a freestall barn is to fix what is broken in the existing freestall barn. All too often cow comfort is compromised by broken or detached freestall dividers and stall structures (Figure 6). Not only can poorly maintained stalls lead to suboptimal stall use but they also can result in serious injuries. Reattaching or repairing stall dividers and structures is a simple step toward improving cow comfort. Sometimes, the best idea is to replace the existing stall dividers with new or slightly used stall dividers that may be more conducive to increased stall use.

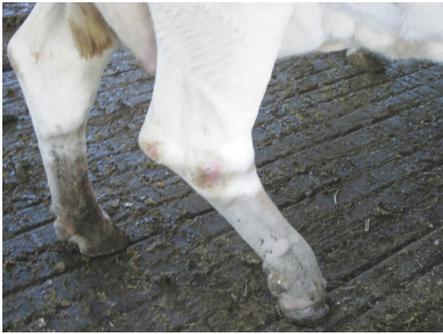
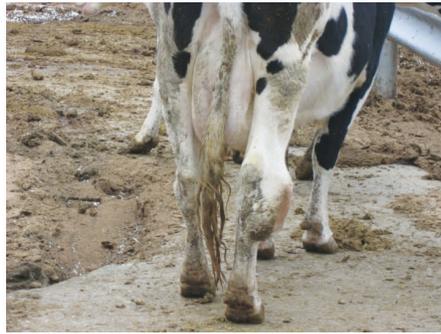
**Figure 7.** When cows do not have an adequate resting surface or when bedding levels are insufficient, the resulting friction to the hocks may result in hock abrasions and injuries. Left, hock abrasion; right, swollen hock.

When cows are not provided with a comfortable place to rest, they will not utilize or occupy the stalls well. Hock injuries are commonly observed in situations where cows are forced to lie on a hard surface or when insufficient bedding is provided (**Figure 7**). The worst scenario is when cows are lying on concrete without any bedding. Bedding

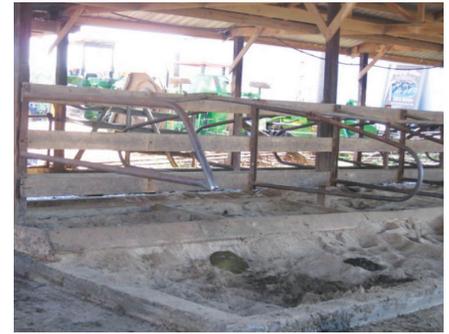
**Figure 8.** Over time, cows will pull sand out of stalls. Sand must be replaced frequently to maintain a comfortable resting area. This dug-out surface needs more bedding.

In deep-bedded stalls, cows may dig out the bedding and reduce their resting area if bedding is not replaced (**Figure 8**). This reduced resting area may also increase the effective height of the brisket board and stall dividers. In turn, cows may have difficulty getting in and out of the stall. Moreover, the potential for

abrasions between the now-protruding rear curb and the cows' hocks can lead to severe hock abrasions and ulcers. When mattress or mats are used, inadequate bedding may also lead to hock injuries and poor stall use. This problem is worsened when the mattress cushions have lost their flexibility and are not replaced when necessary.

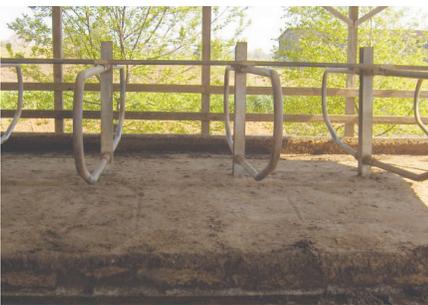
**Figure 9.** Although mattresses provide cushion for cows, bedding is still essential. These mats have little to no bedding on top.

time was 1.15 hours longer when sand stalls were filled to the top of the curb compared to stalls with sand levels 2.44" below the curb. Although mattresses, waterbeds, and mats may reduce the amount of bedding needed, bedding still must be used to minimize friction while the cow rises from the stall and to absorb moisture (**Figure 9**).

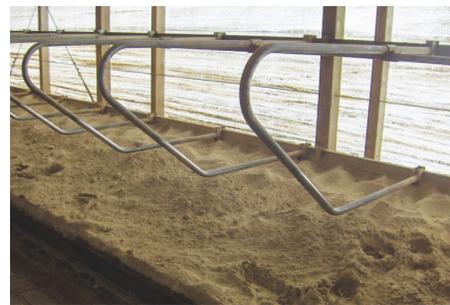
**Figure 10.** Deep bedding minimizes potential for hock injuries, improves stall usage, and increases lying times. The amount of bedding in these stalls is adequate.

no sawdust. Lying time can be improved considerably by providing cows with more bedding (**Figure 10**).

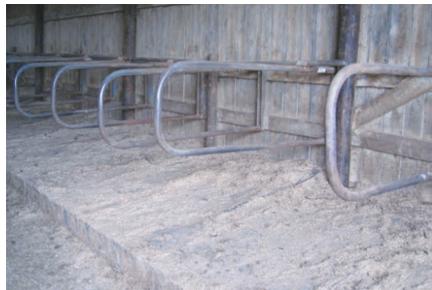
**Figure 12.** Forward lunge space is often blocked by walls or boards placed in front of the cow's resting space.

Forward lunge space is often blocked by walls or boards directly in front of the cows' heads (**Figure 12**). Generally, cows prefer to lunge forward when rising from a resting position, and when obstructions are placed in front of the cows, there is no room for their heads to move in this natural rising motion. When cows cannot lunge forward, they may have difficulty rising from stalls or may even become trapped against the wall while rising. Standing or lying diagonally in the stalls may also be a sign of cows searching for a way to preserve forward lunge space. Dog-sitting, where cows sit like dogs with weight placed on the rear end of their body and their front legs extended, may indicate a lack of lunge space (**Figure 13**). Stalls that lack adequate lunge space are also characterized by overall poor stall usage and may contribute to perching (standing with front legs in the stall and rear legs in the alley).

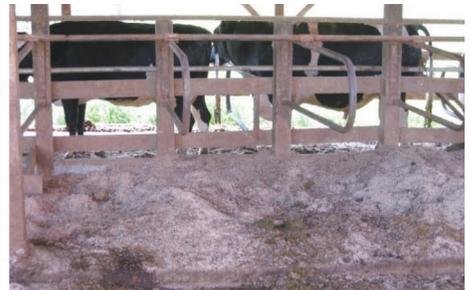
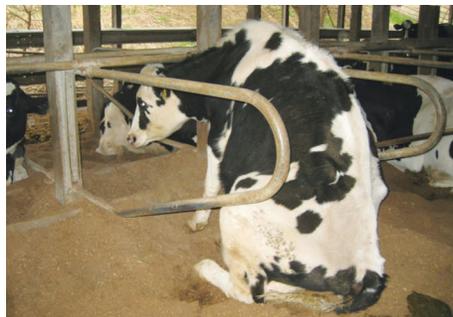
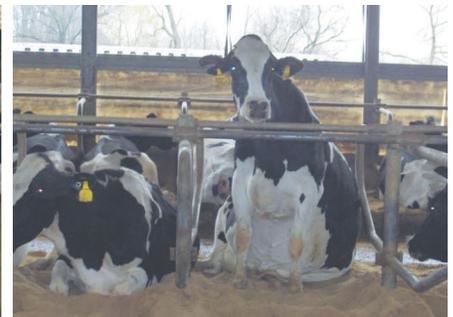
**Figure 13.** Dog-sitting may indicate a lack of lunge space or other freestall design problems.

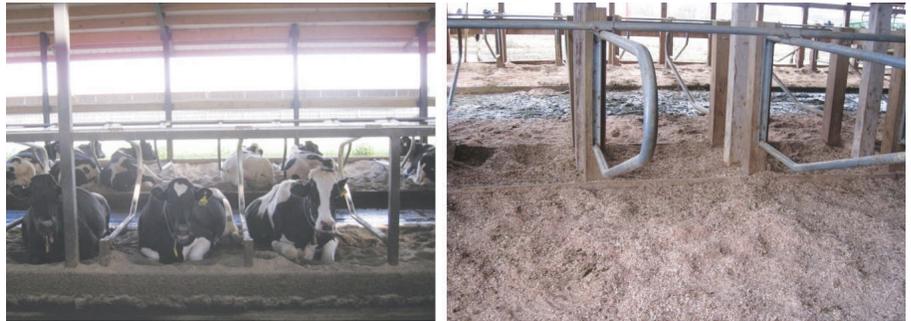
**Figure 14.** Lunge space can be preserved by keeping the area in front of the cows' heads free of obstructions.

The key to solving the problem of inadequate forward lunge space is to remove the lunging obstacles (**Figure 14**). For head-to-head stalls or inside stalls, remove walls and boards that may impede lunging, leaving at least 6 inches above the stall surface and 32 inches of vertical clearance. Depending on how the stall dividers are attached to the support structure, removing these obstacles may require moving posts or modifying where the stall dividers are attached. According to McFarland, if stalls are located on an outside wall, a sloping adjustable sidewall curtain support along the outside wall will give cows ample opportunity to lunge forward while still protecting them from adverse weather.

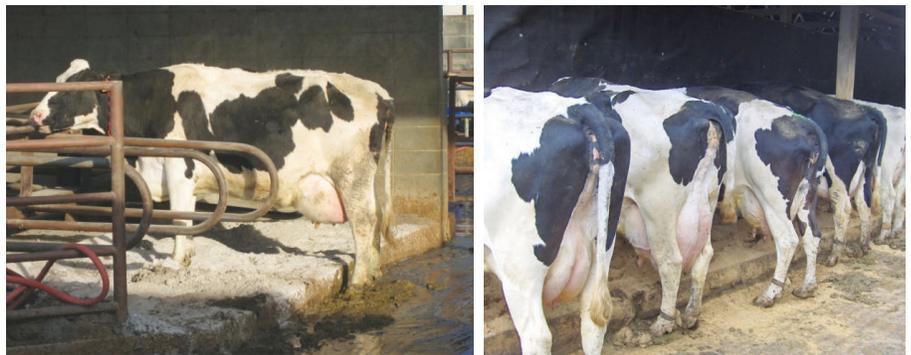
**Figure 15.** Examples of "perching" with cows standing half in and half out of stalls. Perching may indicate that the neck rail should be moved.

One way we can evaluate neck rail placement is by observing cows for perching behavior. "Perching" is when cows stand with their front feet in the stall and their rear feet in the alley behind the stall (**Figure 15**). Generally, this behavior indicates improper neck rail placement. When the neck rail is too low, cows will sometimes stand with their head above the neck rail. If the bottom side of the neck rail has a polished appearance, the cows are likely hitting their neck against the neck rail when rising from the stall. If neck rails are too low, cows may also be hesitant to enter the stalls and may have difficulty

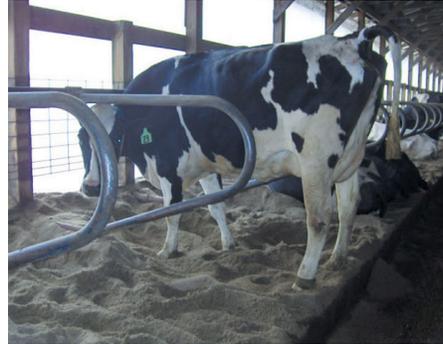
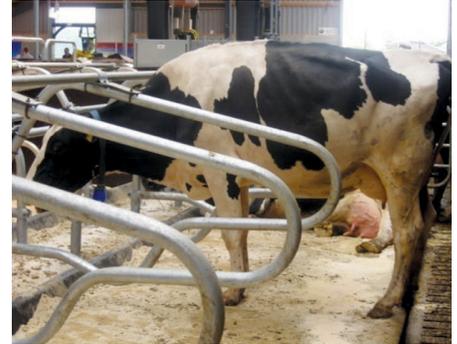
**Figure 16.** Examples of freestalls with proper neck rail placement. Notice that most cows are standing with their four feet squarely placed in the freestall.

of the neck rail (also referred to as neck rail height) should be 48 to 52 inches. The horizontal distance from the alley side of the rear curb to the neck rail (also referred to as neck rail length) should be 68 to 70 inches.

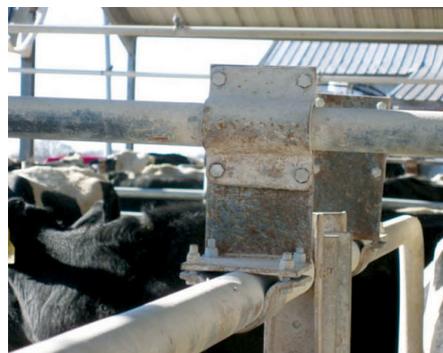
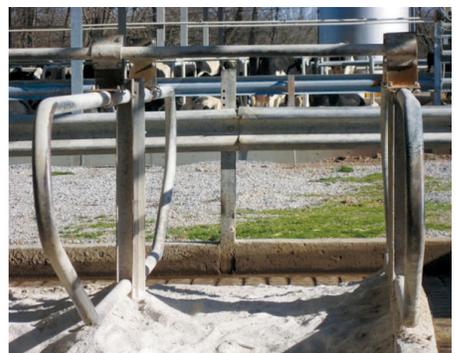
**Figure 17.** An example of a welded pipe fixture used to raise the height of a neck rail.

In many situations, the neck rail can be moved without any major modifications. Increasing or decreasing the neck rail length generally involves unbolting the neck rail and moving it forward or backward along the stall divider to the desired length. Increasing the neck rail height may be a bit more challenging. Dairy producers should use their engineering ingenuity to determine the best modification for their facility. McFarland suggests wood blocks, box steel, welded pipe fixtures (**Figure 17**) and clamps as examples of strategies that may be used to raise neck rail height. In some situations, it may be possible to move the entire stall divider

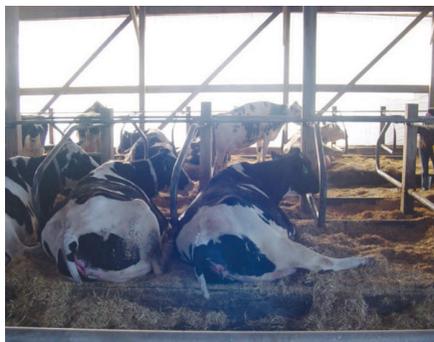
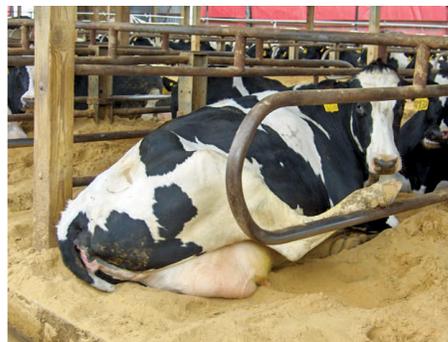
**Figure 18.** When stalls are too narrow, cows may lie diagonally or come into direct contact with the stall dividers or structures while resting.

When cows invade the space of cows in adjacent stalls or prevent the use of the adjacent stall because they are taking up part of the stall, stalls are likely too narrow. Stalls that are too narrow are often characterized by excessive body contact with the stall divider while lying down and rising from the stall (**Figure 18**). Cows may also not use stalls well, and they may lie diagonally.

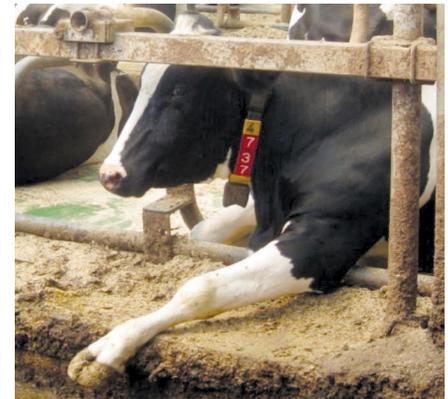
**Figure 19.** Cows often extend their front leg over the brisket locator while resting. To allow for this behavior, a brisket locator with rounded edges is preferred over sharp or straight edges.

the stall. In mattress or mat freestalls, the brisket locator should be 68 to 72 inches from the rear edge of the mattress or mat. In deep-bedded freestalls, the brisket locator should be 68 to 72 inches from the cow side of the rear curb. The best brisket locator is one that provides the cow with an opportunity to extend her front leg over the locator while resting (**Figure 19**).

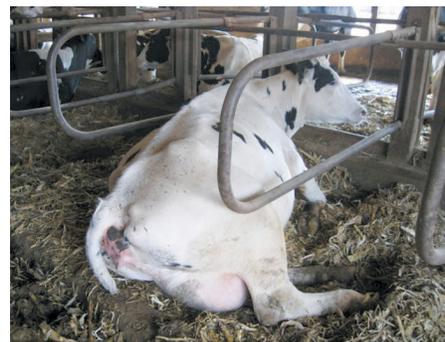
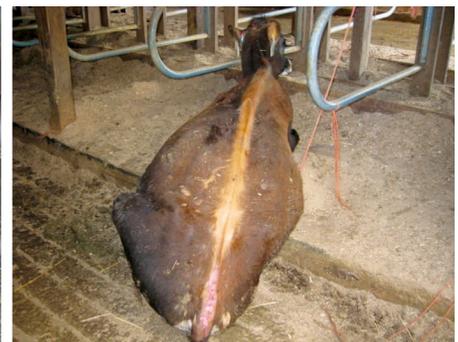
**Figure 20.** When cows do not have enough space to lie down, they may be found lying diagonally in stalls or half-in and half-out with the front part of their body on the stall surface and the rear part in the freestall alley.

The most obvious sign of short stalls is when the cow's rear end hangs over the edge of the curb (**Figure 20**). Short stalls may also cause poor stall usage. Cows may exhibit diagonal standing, lying, and rising as well as perching.

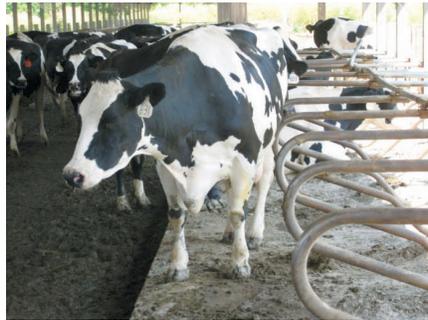
**Figure 21.** If too much space is left between the stall divider and the rear curb, cows may be able to walk on the stall surface.

The primary sign of having too much space behind the stall divider is the observation of cows walking behind the stall divider on the stall surface (**Figure 21**). Cows may often be seen lying backwards in the stalls (**Figure 22**). Both of these behaviors may lead to dirtier stalls. Too much space behind stalls may also increase the likelihood of cows becoming trapped under the stall divider.

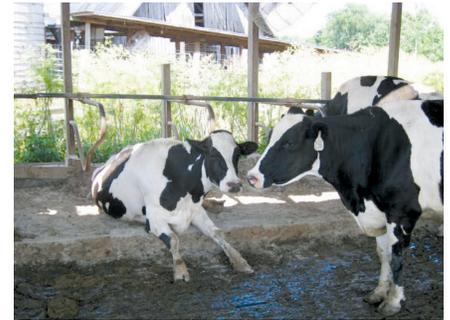
**Figure 22.** When space is open at the end, cows may be more apt to lie backward in the stall.

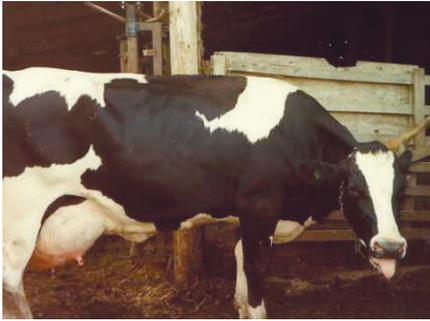
**Figure 23.** Cows housed in barns with poor ventilation are more likely to be affected by heat stress.

Poor ventilation may result in cows expressing obvious signs of heat stress (i.e. panting, breathing heavily) during warmer temperatures (**Figure 23**). Cook et al. illustrated that mean lying time decreased from 10.9 to 7.9 hours per day

as temperature increased. Thus, stall usage may change in warm temperatures if barns are inadequately ventilated.

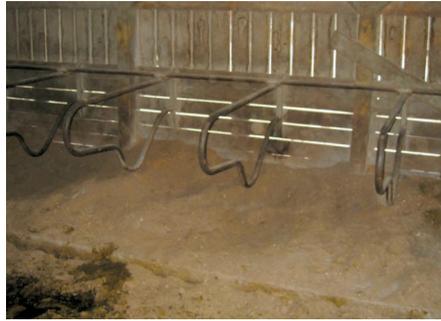
**Figure 24.** Barns that are completely enclosed do not allow for adequate air exchange, resulting in a damp, dark environment, and can lead to heat stress, respiratory problems, and increased transmission of disease.

diseases (**Figure 24**). Palmer found that lack of proper ventilation can lead to high moisture levels, manure gases, pathogens, and dust concentrations that create an adverse environment for dairy cows.

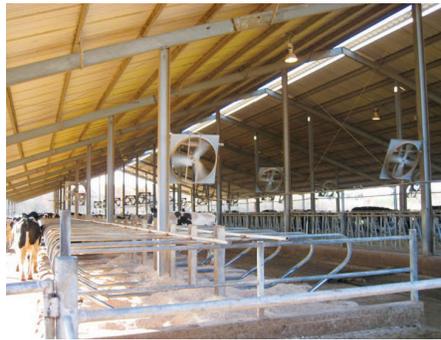
**Figure 25.** The ideal freestall barn maximizes natural ventilation with high, open sidewalls and a ridge vent opening and supplements natural ventilation with fans used to increase air flow and exchange.

Exhausted air generally leaves the barn through sidewalls or ridge openings. Although old barn designs suggested closed-in barns, current recommendations are to open the barns up to allow for better air exchange. Sidewalls allow for air, heat and humidity to be easily and continuously removed from the barn, which is particularly critical during the summer (**Figure 25**). If producers are concerned about the potential negative effects of open sidewalls during the winter, sidewall curtains that can be

A ridge opening should be provided at the top of the building to facilitate air removal through the top of the barn. Warm, moist air rises and exits through the ridge opening even on calm days. The steeper the roof slope the better the movement of the warm moist air out of the ridge vent. The roof slope should be at least 3/12, or 3 inches of rise for
